30th EWG-IE & 5th EWG-OOE Meetings

Book of Abstracts

30th Meeting of the European Working Group on
Internal Erosion in Embankment Dams, Levees and Dikes, and
their Foundations

5th Meeting of the European Working Group on
Overflow and Overtopping Erosion

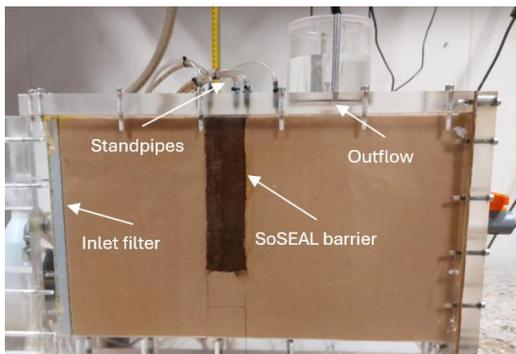
Figure 1. Side view small-scale model.

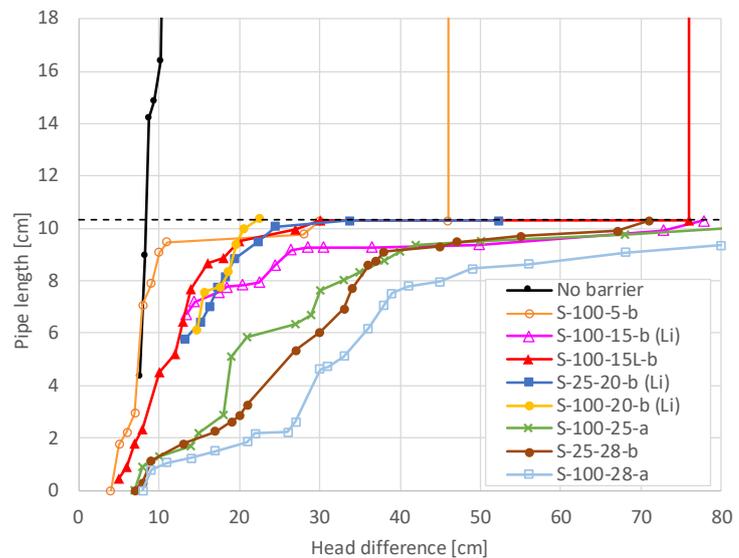
Figure 2. Overview results piping tests

Comparison between laboratory and numerical results shows that the software D-Geo Flow strongly underestimates the pipe length for all tests. Two main reasons could explain what observed. In the numerical model erosion progresses when the groundwater flow is sufficient to transport the particles horizontally inside the pipe; the vertical force that can affect the detachment of the grains from the bottom is not included in the erosion criteria of the model; this component could become dominant when a barrier forces the flow to bend upwards. The second reason is that the 3-d aspect is neglected in the software, which assumes 2-dimensional flow. It is well known that 3-d effects cause longer pipes by equal load (Allan, 2018).

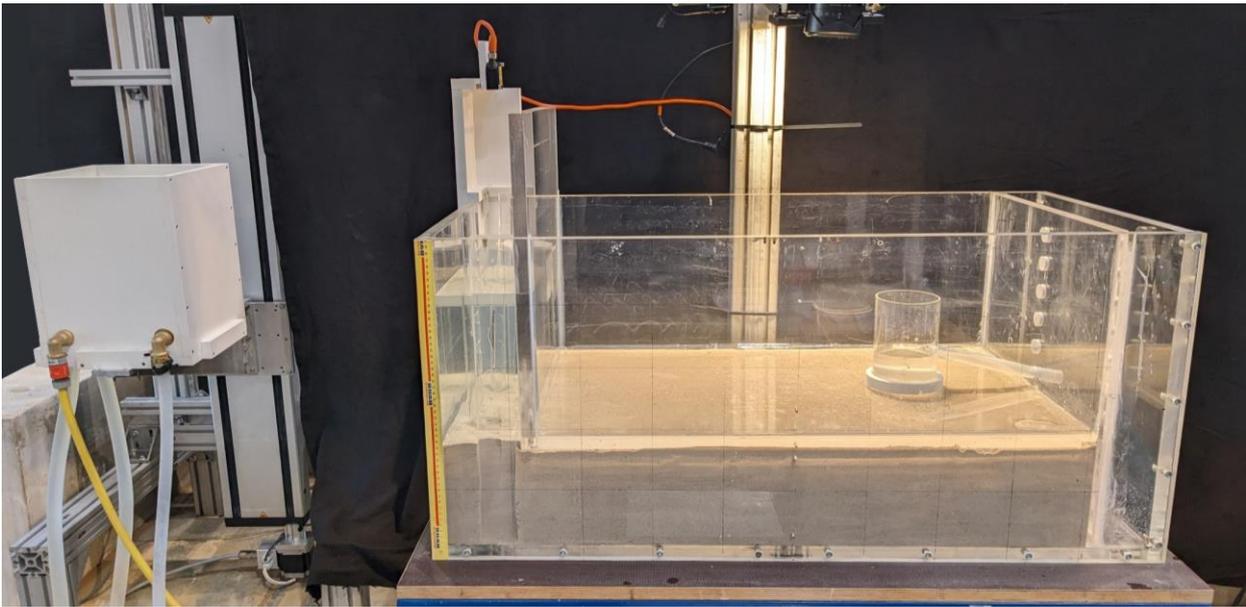
Figure 1. Photo of the experimental BEP setup in the hydraulic laboratory of the TU Dresden

The model has internal dimensions of 800 mm in length, 500 mm in width and 170 mm in depth. The height is adjustable and can be decreased or increased. The height-adjustable cover allows vertical inflow into the pipe to vary, as it is expected that a greater aquifer thickness will provide more vertical inflow into the pipe. The actual levee or dam body is not represented in the planned experiments as it is generally assumed that the seepage flow there can be considered negligible. The flood protection structure is therefore replaced by an acrylic cover so that the erosion process can be visualized. While in most BEP models the sand is deposited and compacted from the side to ensure a sufficient contact with the cover, a conscious decision has been made to fill the setup from above to ensure a better representation of the horizontal layering of the sand. The cover is therefore removable and can be reinstalled once the sand has been installed. In addition, a thin layer of agar was applied to the cover. Agar is a galactose polymer that can be processed into a transparent, elastic

and sufficiently mechanically stable gel, which ensures adequate contact between the sand and the acrylic cover. The completed model setup with installed sand is shown in Figure 1.

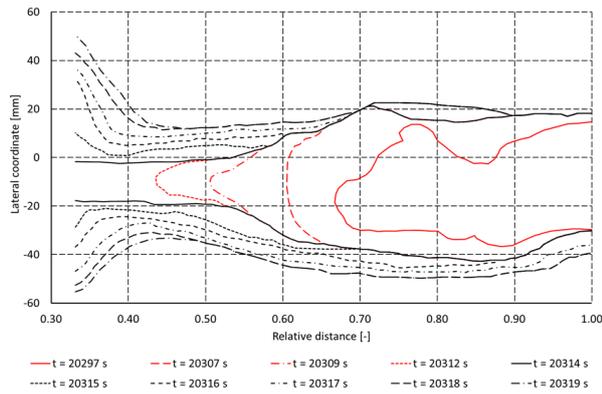
Figure 1. Changes in pipe shape during BEP.

It was found that the local gradients at the tip of the pipe were about 2.4 times higher than the mean gradients in the soil sample. However this ratio will be really higher as measured gradients at the tip were determined using the piezometric heads measured in the standpipes with the span of 2 cm.

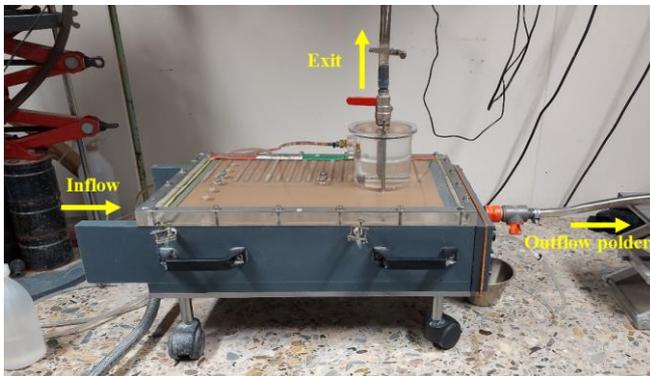
Figure 2. Experimental setup.

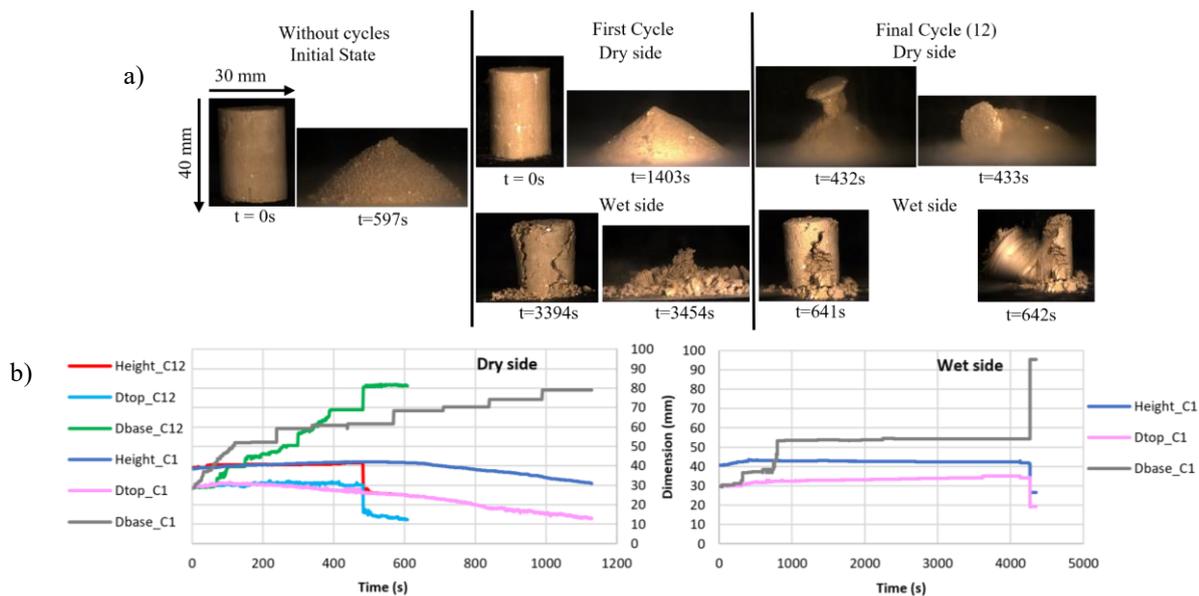
Figure 1. (a) Example of the evolution of soil behavior in the initial state, first and last cycle for both dry and wet cases. (b) Example of the variation in specimen dimensions during the first and twelfth cycle.

particles. From 1 to 6 cycles, specimens disaggregate from the top. After 6 cycles, it disaggregates from the middle and breaks into two parts. On the wet side, the behavior of the soil changes completely. Cracks are formed until they intersect and break the specimen. The velocities of formation and propagation of these cracks quickly increase with the number of cycles.

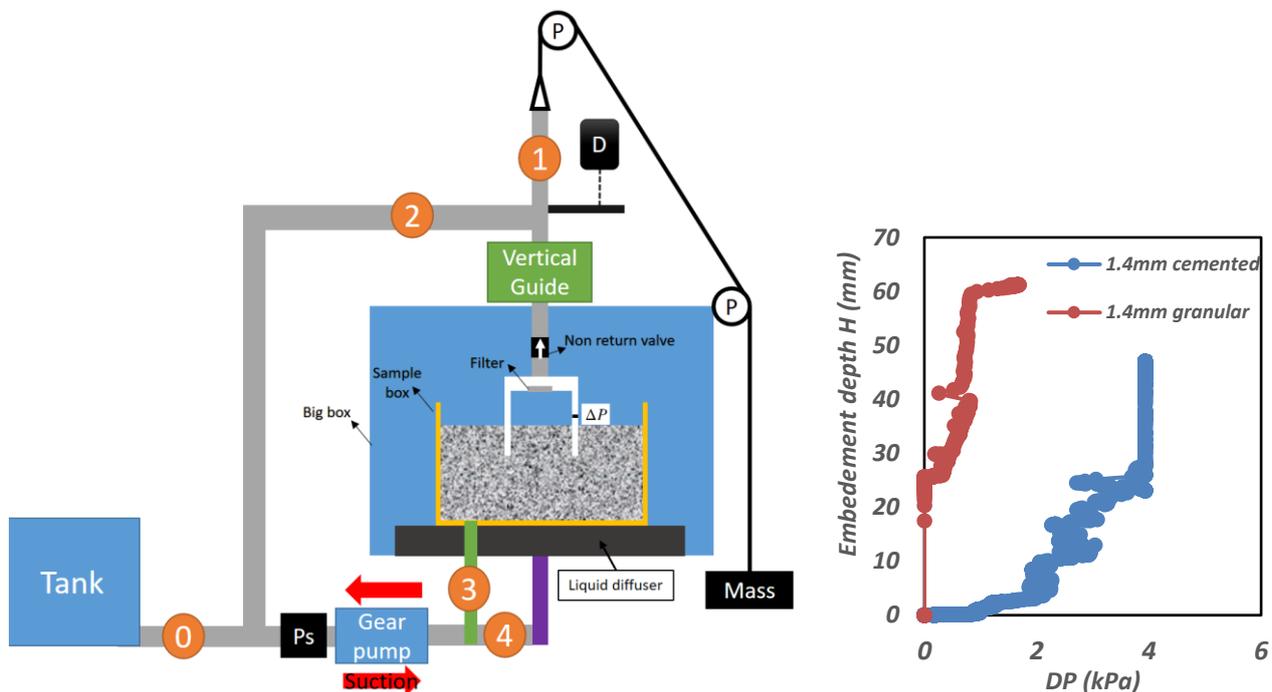
Figure 1. (left) Suction bucket physical model, (right) experimental findings of 1.4mm of the embedment depth versus differential results for fully granular and fully cemented soil.

(1.4 mm, 2.54 mm, and 3 mm), and by fixing the bucket vertical position and varying the particle size (1.4 mm, 2.54 mm, and 3 mm). The results are quite systematic and repeatable for both set of studies. For the case of cemented soil, the sample is constructed by adding paraffin to the granular beads using the method explained in (Farhat et al,2024). A parametric study was conducted by varying the self-weight of the bucket (0 N, 10 N, 20 N) and the particle size (1.4 mm, 2.54 mm, and 3 mm) with three different paraffin contents (0.1%, 0.2% and 0.3%).

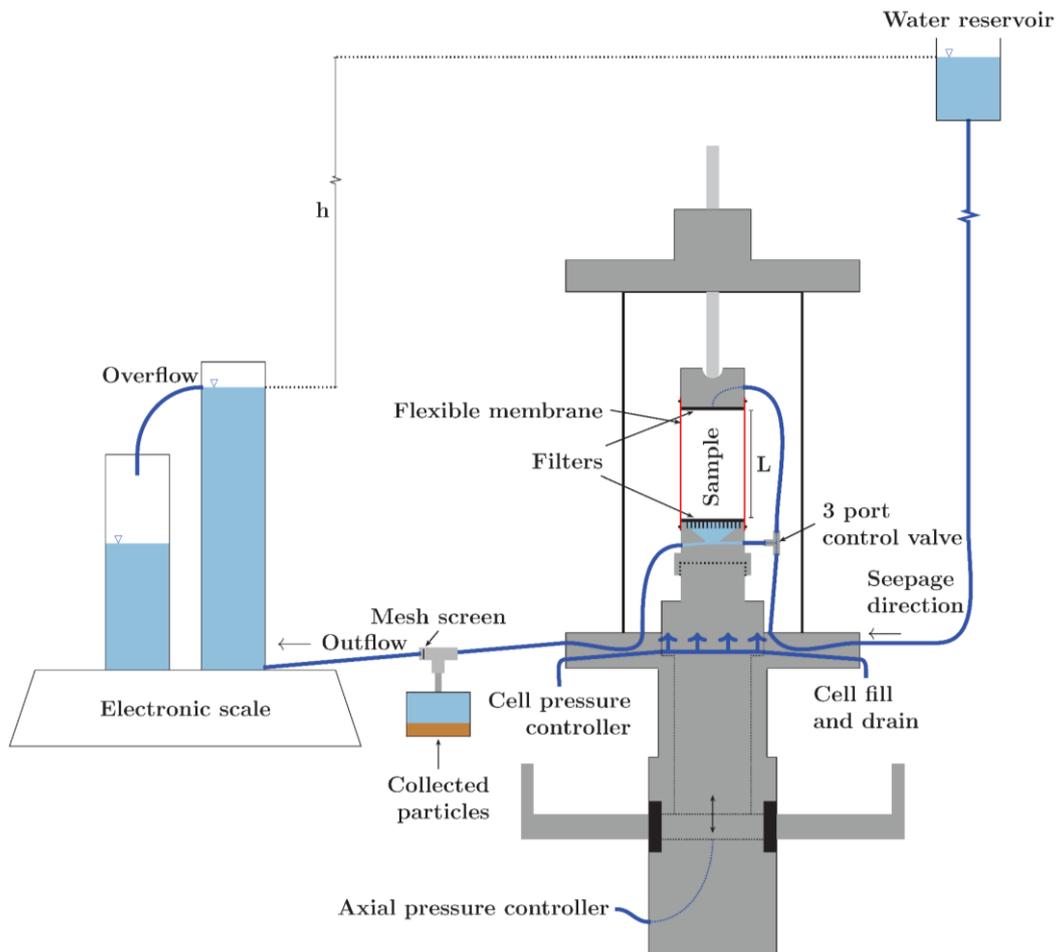
Figure 1. Stress-controlled suffusion device for 50 mm samples with collection of migrated particles.

The planned testing includes confining stresses between 100-500kPa and hydraulic gradients up to 10. The tested material will be an angular filter material. The collected migrated fines will be analysed regarding shape using image analysis. If the shape of the migrated particles deviates from the shape of the particles of the main sample, it can be concluded that breakage has occurred.

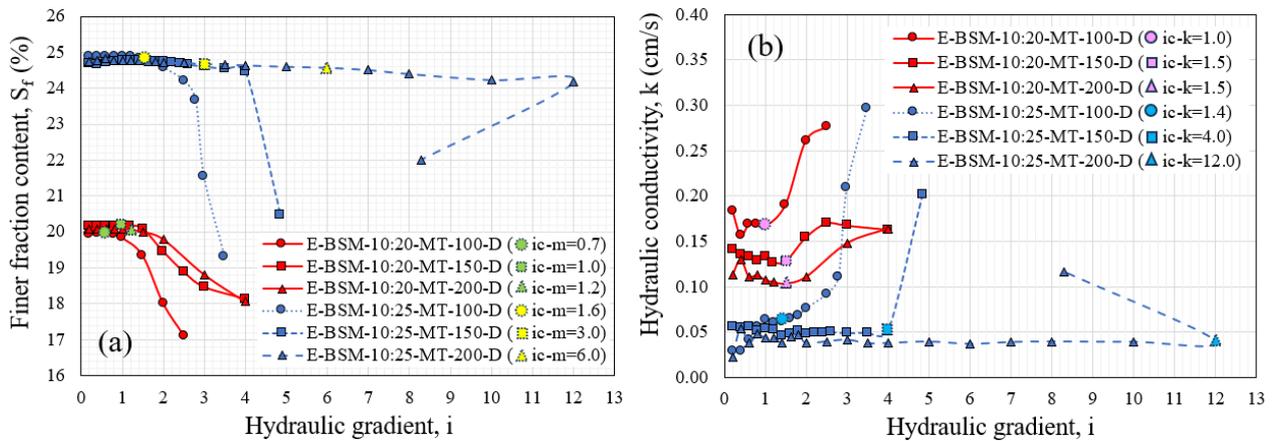
Figure 1. Suffusion response of the gap-graded sands with multistage downward seepage: (a) S_f - i and (b) k - i

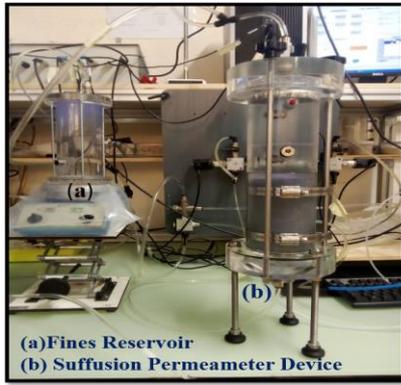
Figure 1. Illustration of the experimental setup used for fines injection.

Injection experiments are performed on a coarse, sub-angular Hostun sand 1/2.5 having a D_{15} of 1.37 mm and C_u of 1.4, which has been used previously to study suffusion (Nguyen et al., 2019). Samples are prepared inside a suffusion permeameter (Figure 1) using the moist tamping method in 7 layers of 2 cm each, at a relative density of 20%. The final dimensions of the sample are 140 mm in height and 70 mm in diameter. Next, Fontainebleau sand, NE34, was sieved to obtain fines corresponding to size ratios of 4.6, 4.9, 7, 8.8 and 11.3. After preparation, samples are initially flushed with CO_2 in-order to improve saturation, and then deaerated water is passed through the sample in the upward direction at a very small flow rate of 50 ml/min. After saturation, an air-tight reservoir filled with water and a predetermined amount of fines (40g) is connected to the permeameter. A magnetic agitator is put inside the reservoir to fluidize the fines and prevent sedimentation before injection. Injection is then performed by applying a downward flow on the samples using a pump, at a constant flow rate of 2500 ml/min. After the completion of injection, the concentration of fines in each layer is obtained by, first, gradually slicing 2 cm thick sections along the height of the specimen. Then, the slices are oven-dried and sieved to determine the quantity of fines. The Fines Concentration, F_c , defined as $m_f / (m_f + m_c)$, where m_f is mass of fines and m_c is the mass of coarse fraction, is computed for each layer to obtain the concentration profile, which is shown in Figure 2 for the different size ratios used in our current study. As can be observed, the concentration profile decays exponentially for the smaller size ratios, 4.6 and 4.9, and hence is very non-homogenous. However, by the time we go to 7, the exponential trend turns linear, and at a size ratio of 11.3, the profile gets closer to homogeneity. The measured fine content was 4.3%, 4.2% and 4.2% for $R=4.6$, 4.9 and 7 respectively, and this dropped to 3.3% for 8.8, and 2.5% for $R=11.3$. For $R=11.3$, multiple rounds of injection were performed and after 3 rounds, we were able to achieve a F_c value of 4.4% at which stage the injection was stopped and the sample was subjected to triaxial tests.

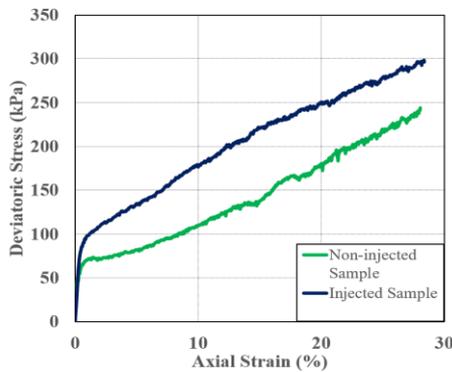
Figure 3. Comparison of the undrained mechanical behavior between injected and non-injected samples in the q - ϵ_a space.

For investigating the effect of the injected fines on the mechanical behaviour, undrained compression triaxial tests are performed on the injected samples as well as on the non-injected ones. For comparison, two set of samples, having a size ratio of 11.3 were chosen. To perform triaxial tests on the injected sample, the sample is first de-saturated and frozen. Then, it is carefully transferred to the triaxial device where it is allowed to thaw under a confining stress of 100 kPa. Next, undrained compression loading is applied under fully saturated conditions ($B \geq 96\%$), effective confining stress of 100 kPa, and a vertical strain rate of 1% per minute. The non-injected and injected samples have the same initial inter-granular void ratio of 0.778. The results of triaxial tests are depicted in Figure 3 and Figure 4. In Figure 3, one can see that the addition of fines has resulted in a significant increase in the undrained shear strength of the injected sample (by ~ 30 kPa). The examination of stress path (Figure 4) shows that the addition of fine grains suppress the existence of a point with q -constant incremental evolution and the subsequent risk of (transient) liquefaction. For large axial strain, both materials (injected and non-injected one) reach the same critical state line, which is probably linked to the fact the mass of injected fine grains remains limited.

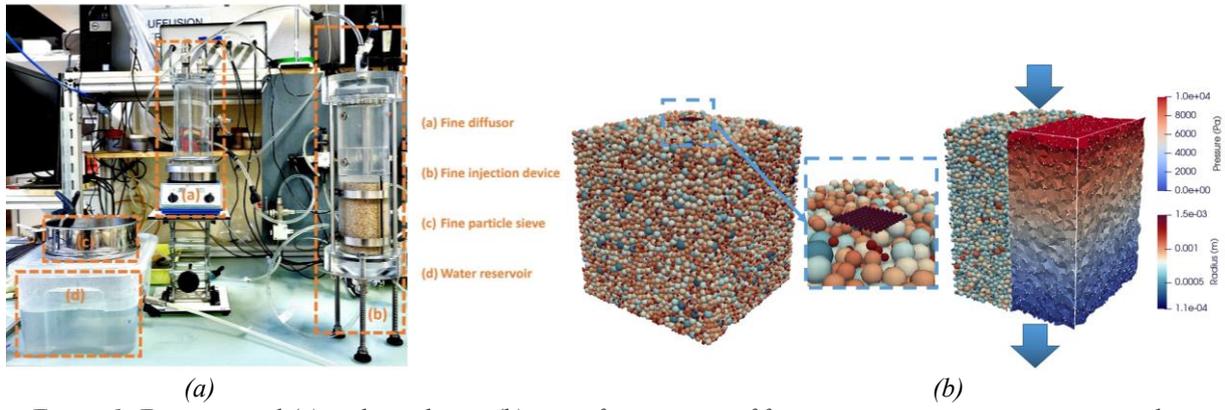
Figure 1. Experimental (a) and simulation (b) setup for injection of fine-suspension into coarse-grain column.

In parallel, a PFV-DEM simulations were conducted. Numerical columns with the same PSD used in our experiments are generated. The fine particles of varying size d were randomly positioned above the column and then released under either gravity or hydraulic force resulting from an internal fluid flow (Figure 1(b)) for the two extreme densities (loosest and densest).

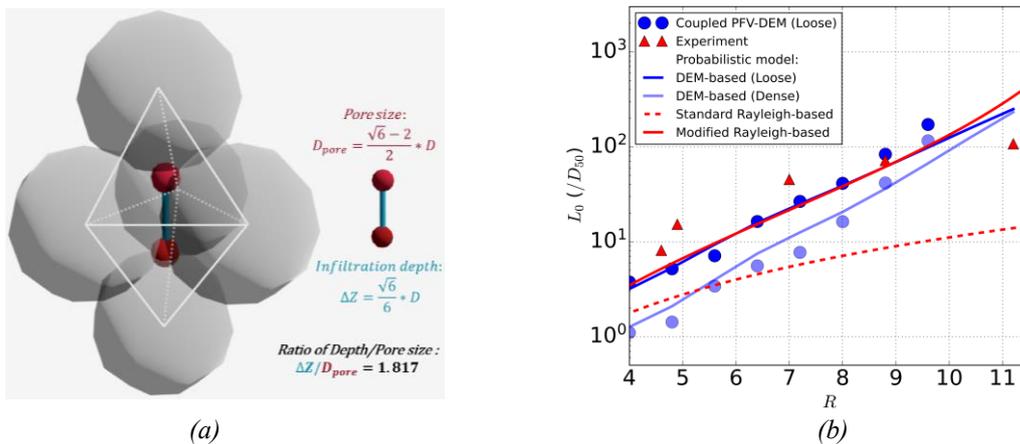
Figure 2. Probabilistic model predicting decaying length: (a) micro-mechanical configuration to calculate ΔZ via D_{p50} ; (b) predicted value of L_0 compared with experimental and numerical results.

This simple probability model is then used to predict the characteristic infiltration depth L_0 under different packing density and size ratio R . Interestingly, this simple probabilistic model is found to predict quite well the L_0 , showing a linear trend for $\log(L_0)$ versus R in both dense and loose columns (Figure 2(b)). This consistency validates the idea that the average probability P_d of fine particles passing through constrictions in soil with a homogeneous pore-constriction network captures the key physics governing their infiltration.

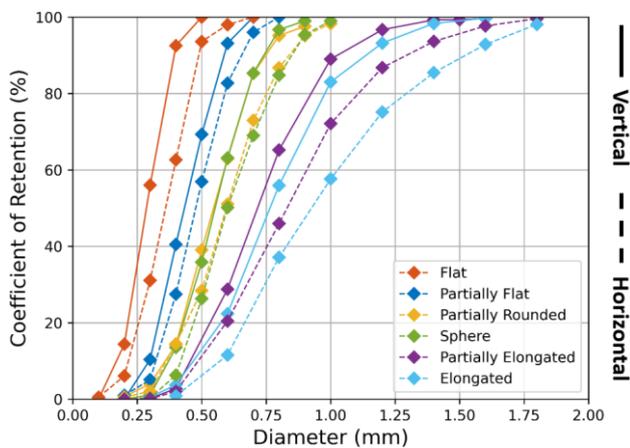
Figure 1: Retention coefficient of the filters with different particle shapes for vertical filtration and horizontal filtration

In conclusion, particle shapes significantly alter the topological and morphological anisotropic properties of granular filters, thus affecting directional filtration processes more than the direction of flow itself. This study highlights the necessity for a comprehensive approach that considers particle shapes to derive filtration properties in order to achieve accurate results. However, this consideration may be oversized in engineering practice.

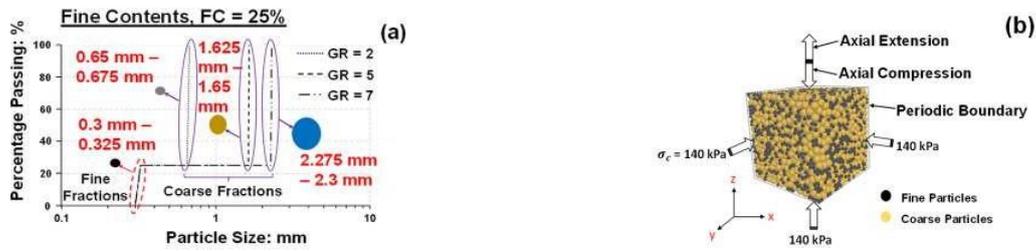
Figure 1. (a) Particle-size distribution curve for varying gap-ratios, (b) DEM sample.

Three-dimensional Discrete Element Method (DEM) simulations were conducted to evaluate the impact of stress paths on the erodibility of cohesionless fines in gap-graded granular soils. Cubical assemblies of spherical particles representing gap-graded soils were used in the simulations, employing Particle Flow Code (PFC3D) (Itasca, 2005). DEM samples were generated using non-overlapping spherical particles. Periodic boundary conditions were used to simulate infinite size and reduce boundary effects (Figure 1(b)). The Hertz-Mindlin contact model, which is ideal for non-cohesive interactions due to its nonlinear elastic properties, was used (Shire et al., 2014). The DEM replicated simulated samples with particle-size distributions for gap ratios (GR) of 2, 5, and 7, combined with a fine content (f_c) of 25% (Figure 1(a)). This approach aimed to encompass a range of stable, transitional, and unstable soil assemblies (Shire et al., 2014; Ahmadi et al., 2020). Power-law distribution functions were used to randomly distribute particles among fine and coarse fractions, excluding gravitational effects to prevent segregation and non-uniformity. During consolidation, all specimens were isotropically confined to a constant effective stress of $p' = 140$ kPa. To create dense specimen, the interparticle friction coefficient was set to $\mu_{f0} = 0.1$, respectively. Once equilibrium was reached, μ_{f0} was restored to 0.5, following common DEM practices (Thornton, 2000; Ahmadi et al., 2020).

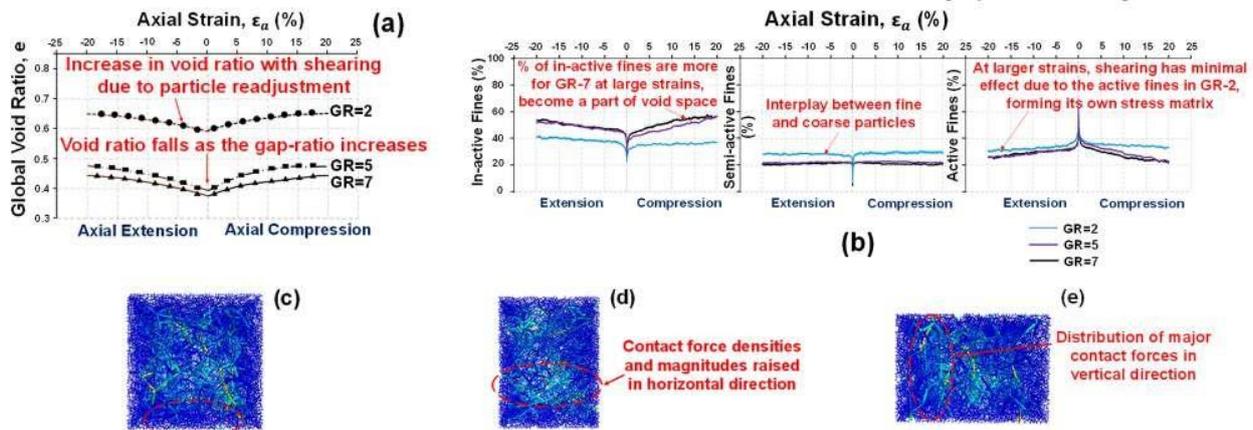
Figure 2. (a) Variation in void ratios across different gap-ratios, (b) Role of fine particle types during shearing based on $Z_{avg,f}$, (c) Contact force chains after confinement stage, (d) Extension, (e) Compression

DEM results show that void ratios decrease in gap-graded assemblies as GR increases from 2 to 7 (Figure 2(a)). Conversely, dense packings exhibit increased void ratios under axial compression and extension stress paths due to particle rearrangement. Motivated by findings that fines with zero or single contacts contribute no stress (Thornton, 2000), this study examined the effect of shearing on inactive fines, or rattlers, based on fabric indicator i.e., $Z_{avg,f}$. Semi-active fines (2 to 4 contacts) provide lateral support in the stress matrix, while active particles (>4 contacts) form a solid skeleton (Ahmadi et al., 2020). For soils with GR=2, fine particle types varied minimally under axial compression and extension (Figure 2(b)). However, higher hydraulic gradients may cause internal erosion due to increased semi-active particles and fewer inactive ones during large strains. In soils with GR=5, variations in inactive fines more noticeably change the soil fabric during initial shearing than compression. In soils with GR=7, inactive fines increase at large strains, resulting in more erodible particles. Axial compression shows that specimens with vertical contact normals are more dilative, stiffer, and less erodible (Figure 2(e)), whereas those with horizontal contact normals are more contractive, less stiff, and highly erodible (Figure 2(d)).

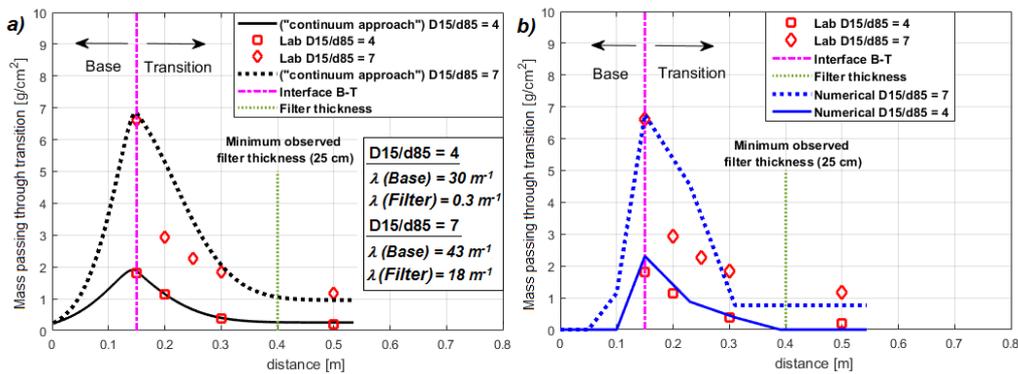
Figure 1. “Mass passing through transition” vs distance according to: a) “continuum” approach; b) PNP.

The continuum approach and the proposed numerical procedure (PNP) have been applied to the lab experimental results obtained by Locke et al. (2001). Particularly, the effects of a downward seepage flow through a system *B-T* composed by a well-graded sand (150 mm thickness), as base soil (*B*), and a well-graded gravel (800 mm thickness), as transition (*T*), are measured. Transition material (*T*) is characterized by *D*15 (particles diameter corresponding to the 15% passing) = 10.1 mm; different base soils (*B*), characterized by *d*85 (particles diameter corresponding to the 85% passing) satisfying the values of the piping ratio *D*15/*d*85 = 4 and 7 (as from *Terzaghi* criterion limits) are tested. The main results provided by the “continuum approach” are “porosity vs distance”, “concentration of suspended particles vs distance”. The PNP, in addition to these “global” variables, also provides information at the micro (*particle*) scale, particularly the GSD and CSD curves. The comparison (Figure 1) between measured and numerical (according to both approaches) values of the “mass (M_{PT}) passing through the transition material [g/cm^2]” is carried out ($M_{PT} = c_s \cdot n \cdot \rho_s \cdot V/S$; ρ_s being the grains density/unit weight; *S*, the area of the sample cross section; *V*, the volume of the sample). The Figure 2 shows the additional results at the microscale provided by the PNP in terms of final GSD and CSD curves at different distances from B-T interface.

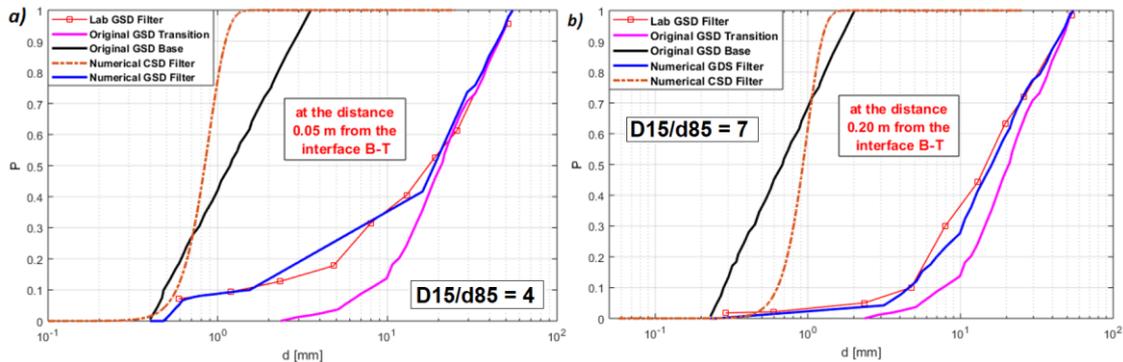
Figure 2. PNP: final GSD and CSD curves of transition (*T*): a) for $D15/d85 = 4$, at the distance from the interface B-T of 0.05 m, b) for $D15/d85 = 7$, at the distance from the interface B-T of 0.20 m.

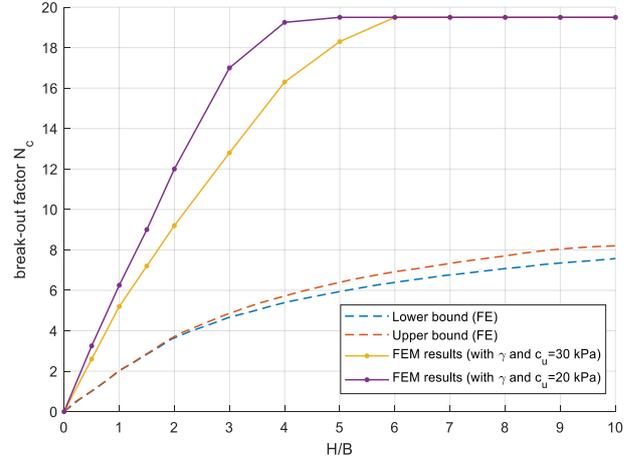
Figure 4. Comparison between homogeneous material FEM results (with unit weight) and upper and lower bound solutions.

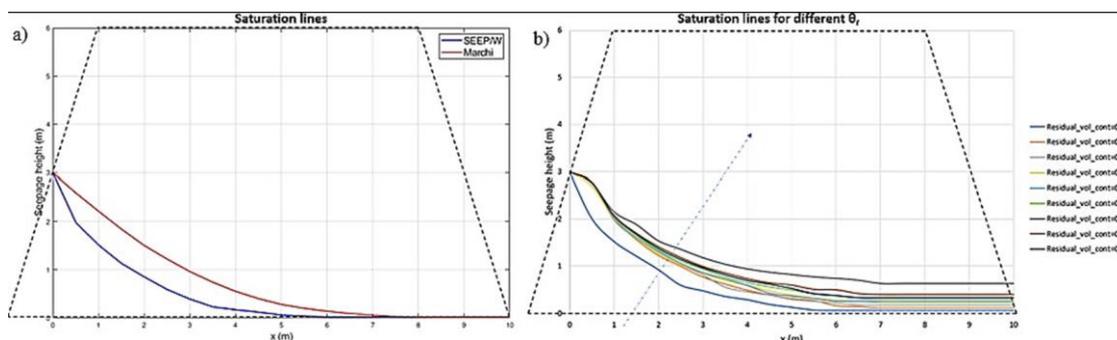
Figure 2. a) Saturation lines assessed with Marchi's equation and SEEP/W (fixing $\theta_r = 0.2$ and $\theta_s = 0.5$); b) Seepage lines considering different residual volumetric water content values θ_r and a fixed saturated water content equal θ_s to 0.5.

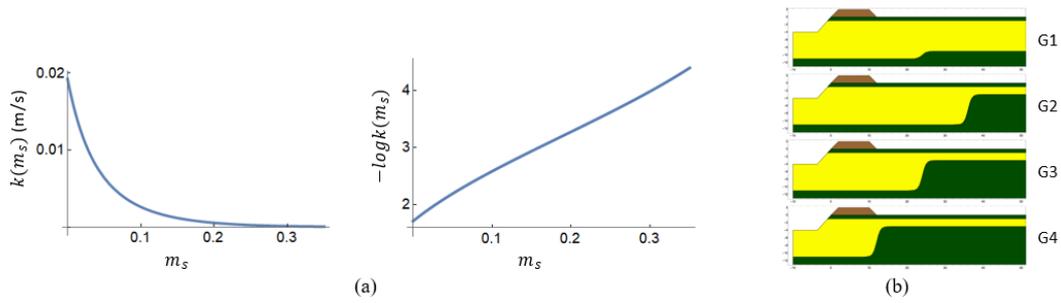
Figure 1. (a) Influence of the sand volume fraction m_s on hydraulic conductivity k of sandy gravel; (b) The four geometries studied deduced from geophysical measurements (Girolami et al., 2023), where the permeable sandy gravel is in yellow ($4 \times 10^{-5} \leq k \leq 2 \times 10^{-2}$), and the low permeability sandy silt is in green ($k=10^{-6}$ m/s).

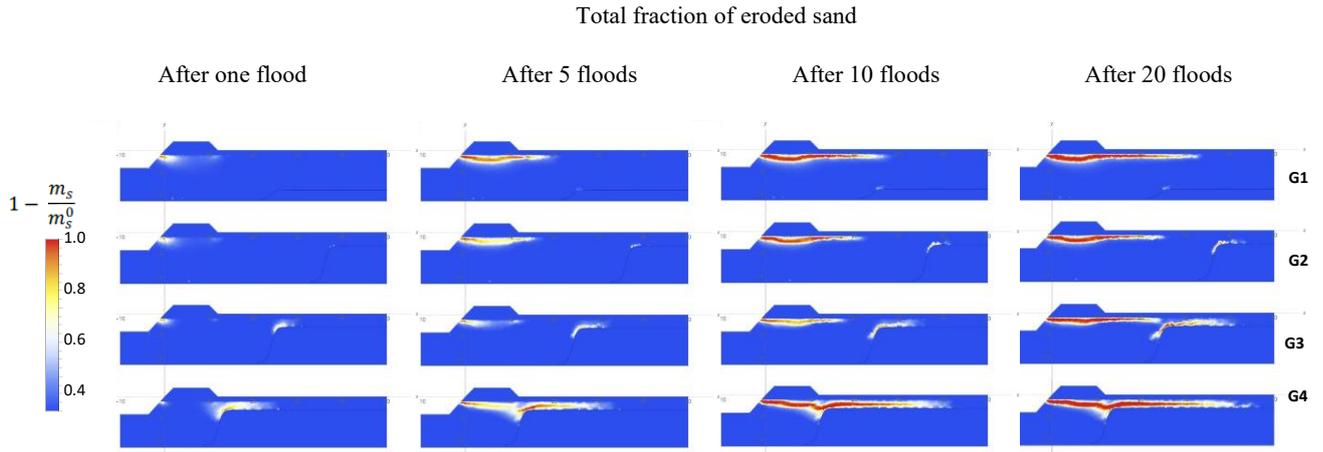
Figure 2. Volume fraction field of eroded sand $1 - m_s/m_s^0$ for the four geometries, at various times.

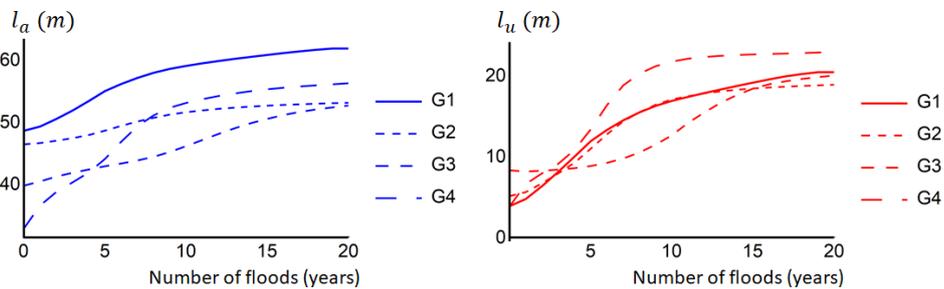
Figure 3. Artesian zone size l_a (promoting leaks and sand boils) and uplift zone size l_u (promoting hydraulic fracturing and fluidisation) in the protected area as a function of the number of floods (and according to time in years if there is one flood per year).

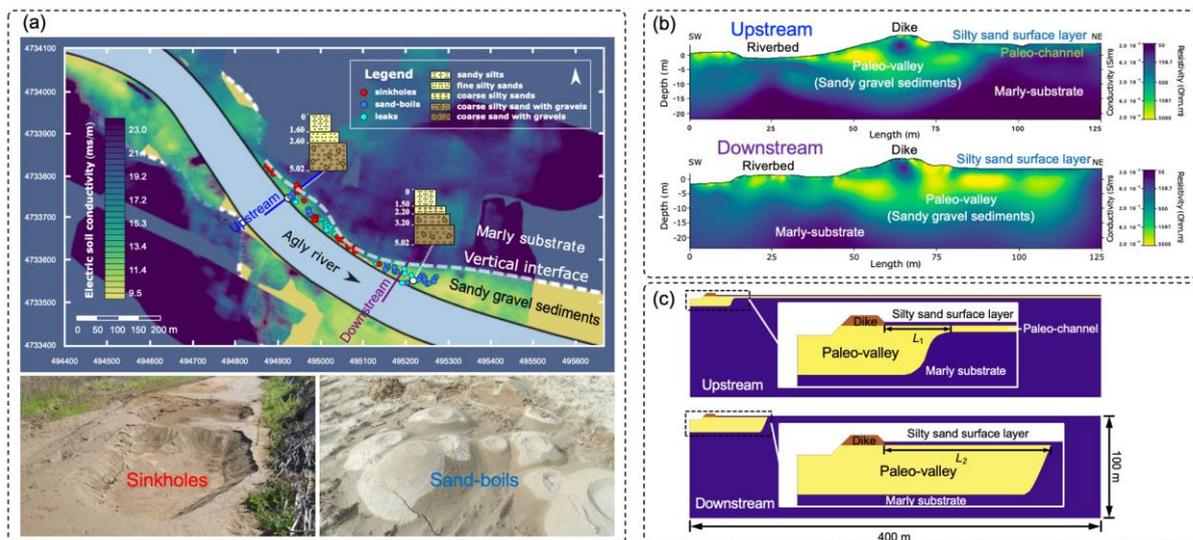
Figure 2. (a) distribution and photo of the erosion signatures, (b) geophysical results; and (c) numerical configurations.

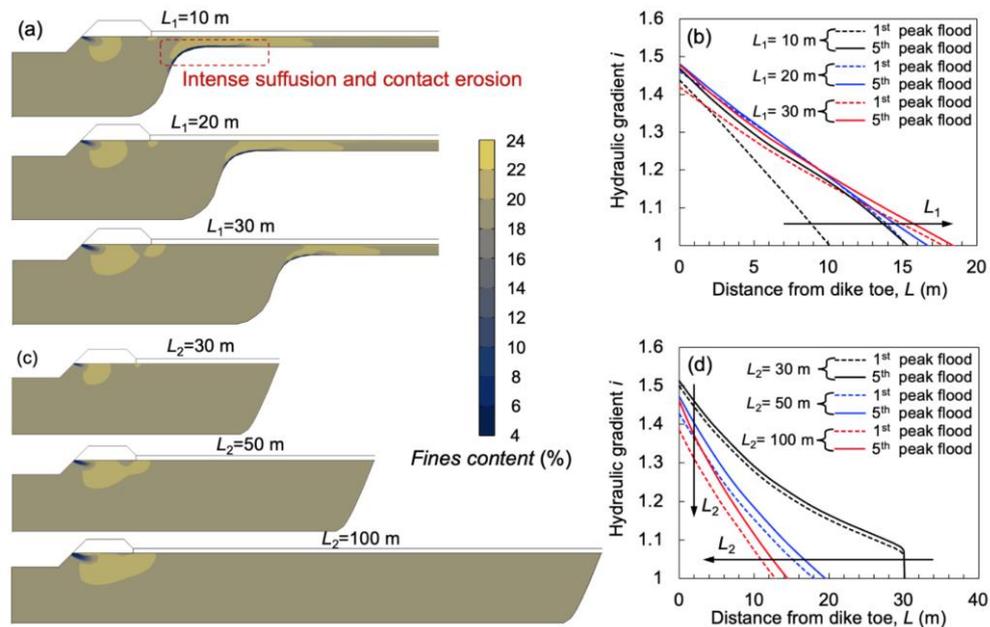
Figure 3. Fines content distribution in sandy gravel sediments and hydraulic gradient distribution in the silty sand surface layer in the upstream area (a-b), and the downstream area (c-d).

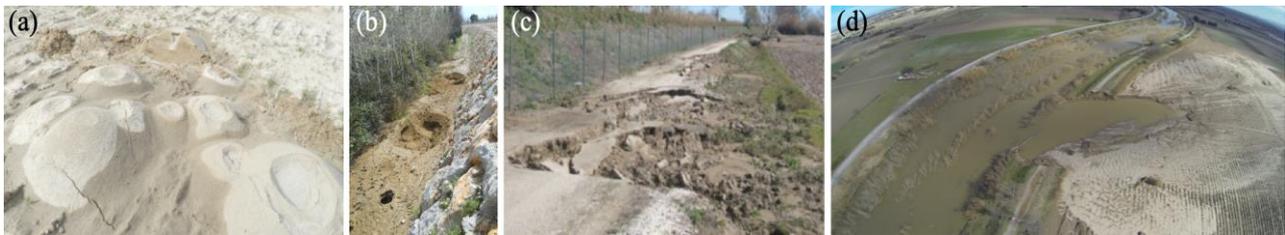
Figure 1. Examples of erosion signatures observed in 2012, 2013, 2014 at the vicinity of dikes at the Agly river during floods: sand-boils (a), sinkholes (b,c), gravitational collapses (d) (Photos INRAe).

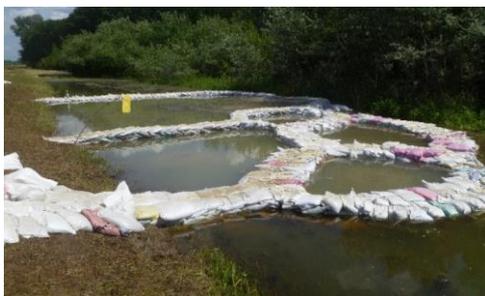
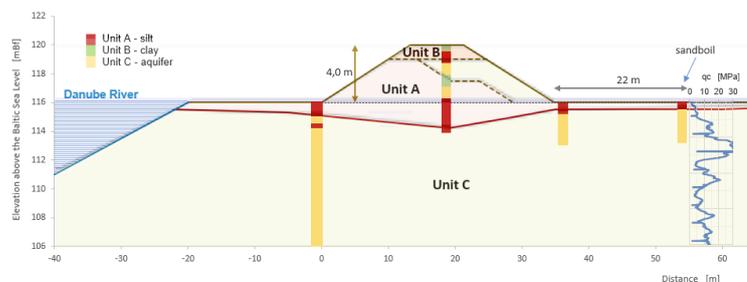
Figure 1. Sandboils along the Danube River. Figure 2. Typical cross-section.

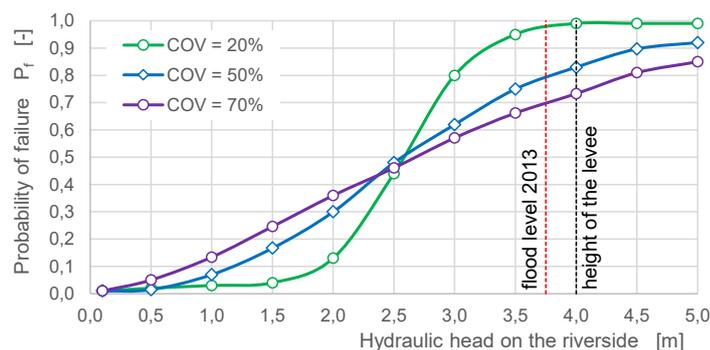
Figure 3. Probability of piping failure.

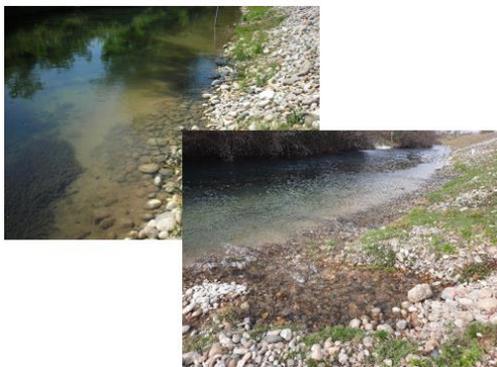
Figure 1. Leakage and fine particles erosion at the earth dam toe (Bourg-lès-Valence, 2007).

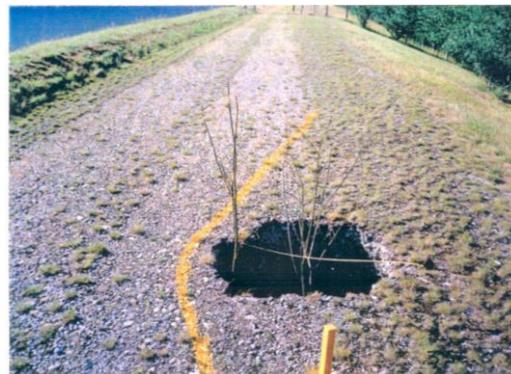
Figure 2. Sinkhole development on the dam crest (Brégner-Cordon, 1991).

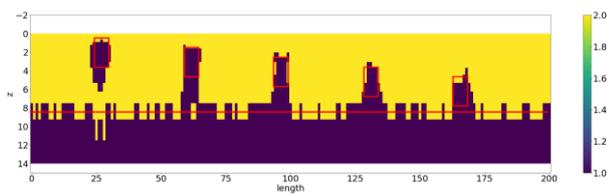
Figure 1(a). The lithological prediction based on the inversion of the DULAEM 842s system. Purple (lithology value of 1) is predicted sand lens. Red outlines show the contacts between sand and clay from the synthetic model.

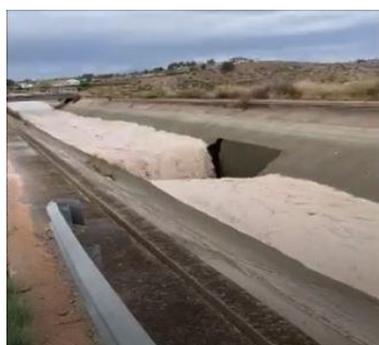
Figure 1: Murcia canal breach, Spain, September 2019

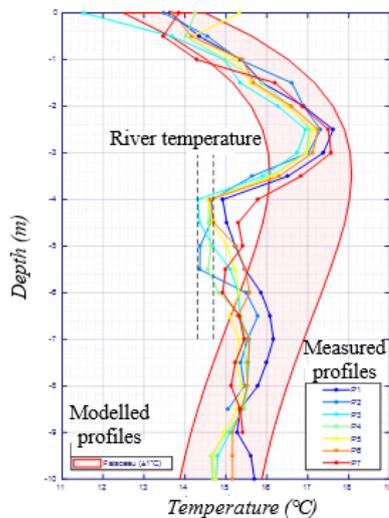
Figure 3. Measured vertical thermal profiles.

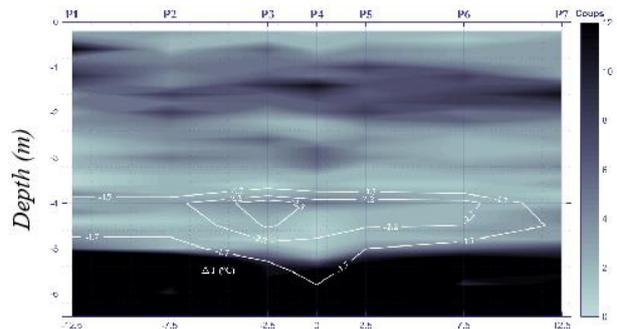
Dike axis, centered on the assumed leaking path
 Figure 4. Superposition of the mechanical resistance mapping around the leak and isotherms of the difference between the measured and the expected temperatures in the boreholes. The x-axis is centered on the assumed leaking path.

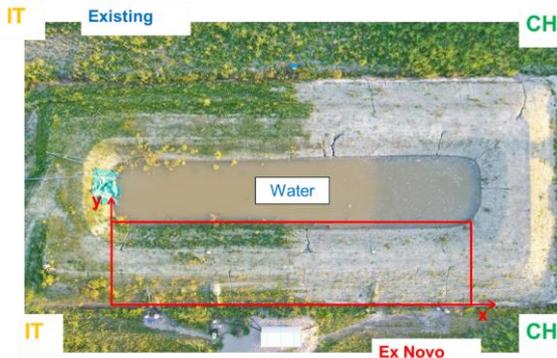
Figure 1. Overview of the test embankment in Boretto.

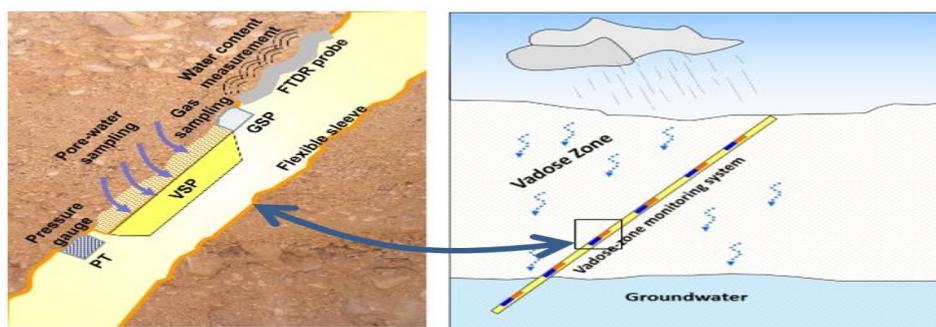
Figure 1. Schematic illustration of a monitoring sleeve installed through the vadose and saturated zones.

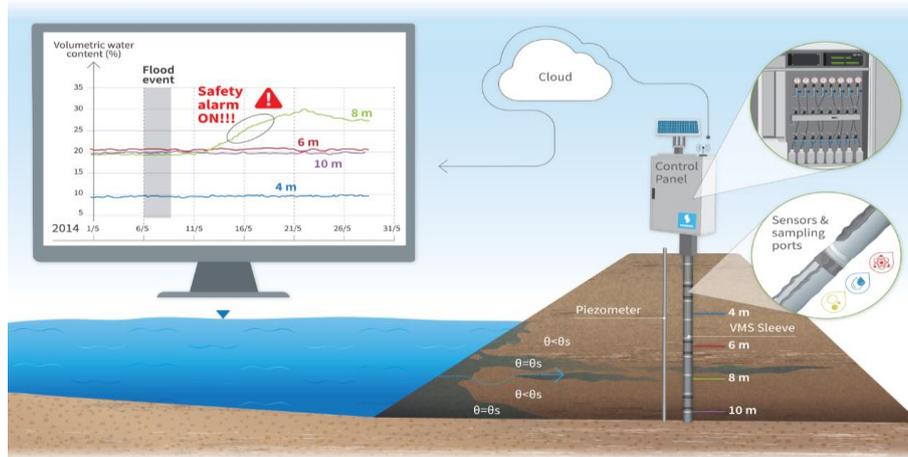
Figure 2. VMS setting for early warning of piping and dam safety.

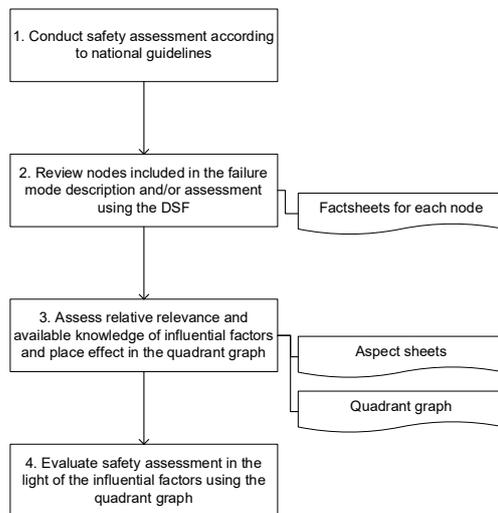
Figure 2. Illustration of envisioned risk assessment process for BEP and provided tools for guidance.

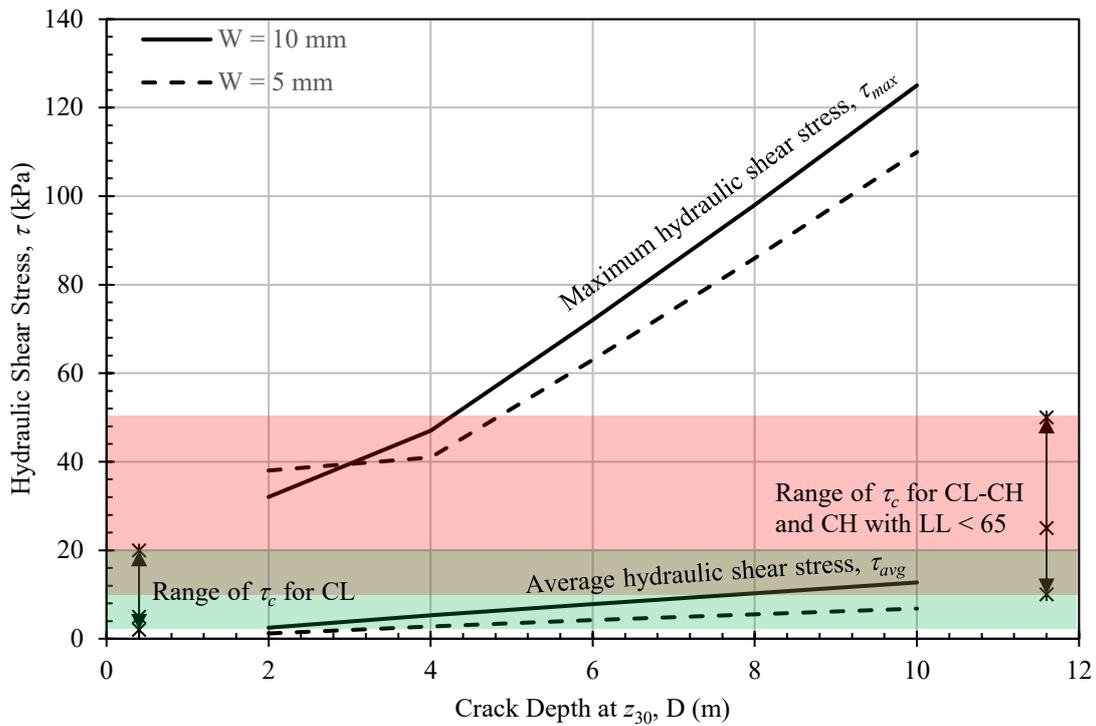
Figure 1. Comparison of hydraulic shear stresses for vertical rectangular cracks.

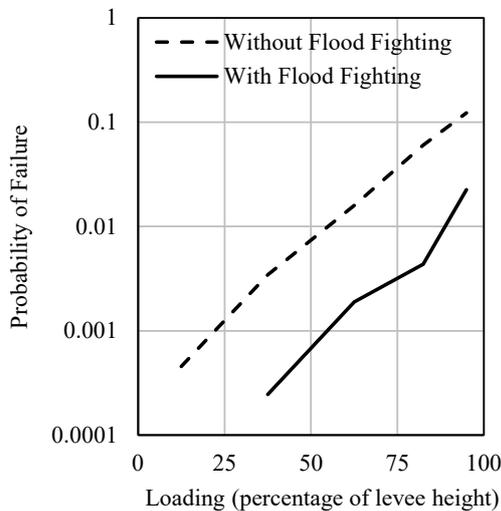
Figure 1. Probability of failure for internal erosion through the embankment.

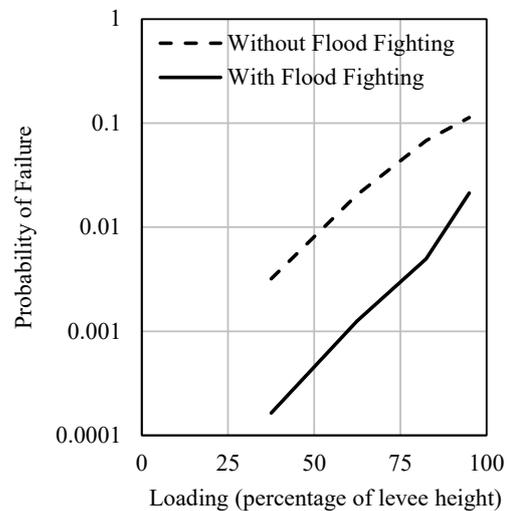
Figure 2. Probability of failure for internal erosion through the foundation.

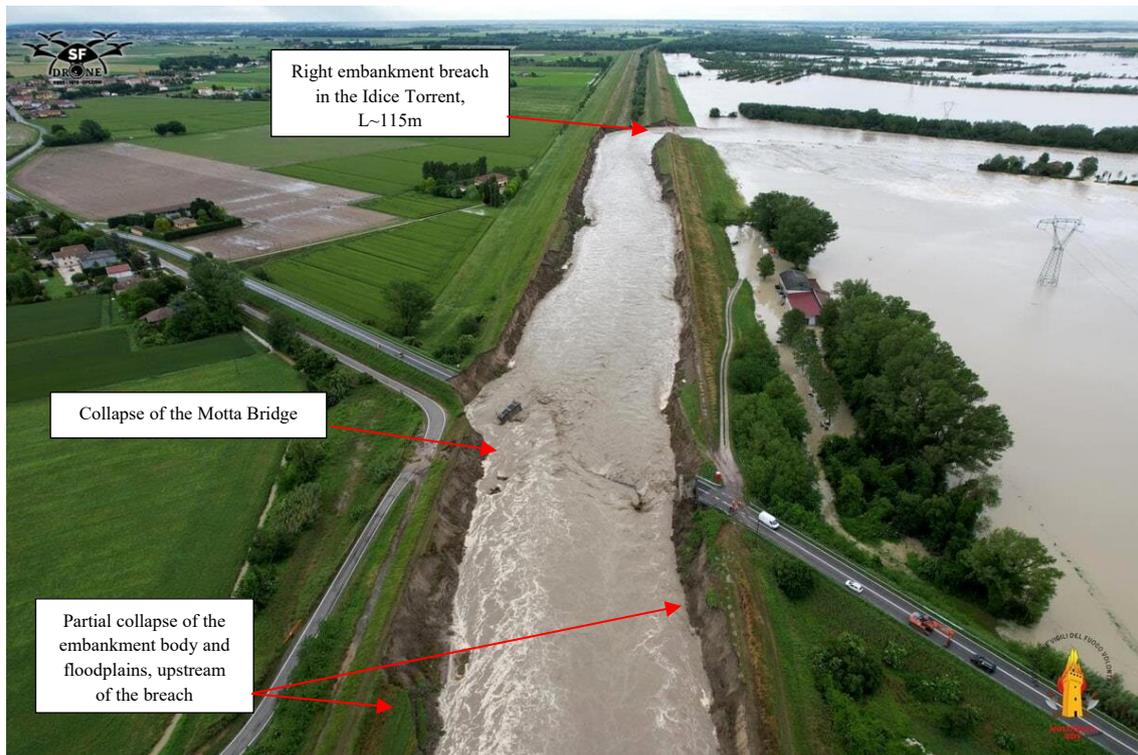
Figure 1. Aerial view of the right embankment breach in the Idice Torrent, collapse of the Motta Bridge and erosion of the riverbanks.

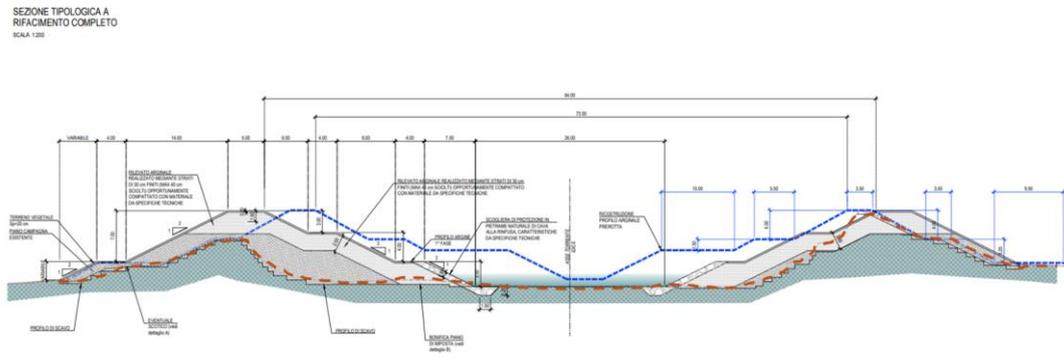
Figure 1. Type A section, complete reconstruction. In blue, the outline of the pre-event embankment; in red, the outline of the post-event embankment.

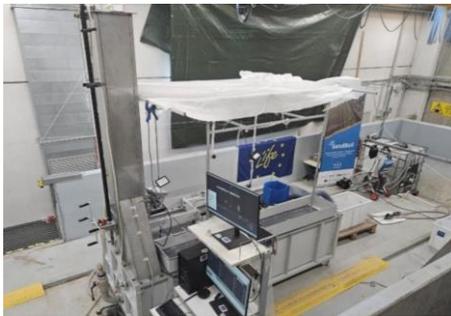
Figure 1. General view of the medium-scale experimental setup at the University of Bologna.
