30th EWG-IE & 5th EWG-OOE Meetings

Book of Abstracts

30th Meeting of the European Working Group on
Internal Erosion in Embankment Dams, Levees and Dikes, and
their Foundations

5th Meeting of the European Working Group on
Overflow and Overtopping Erosion

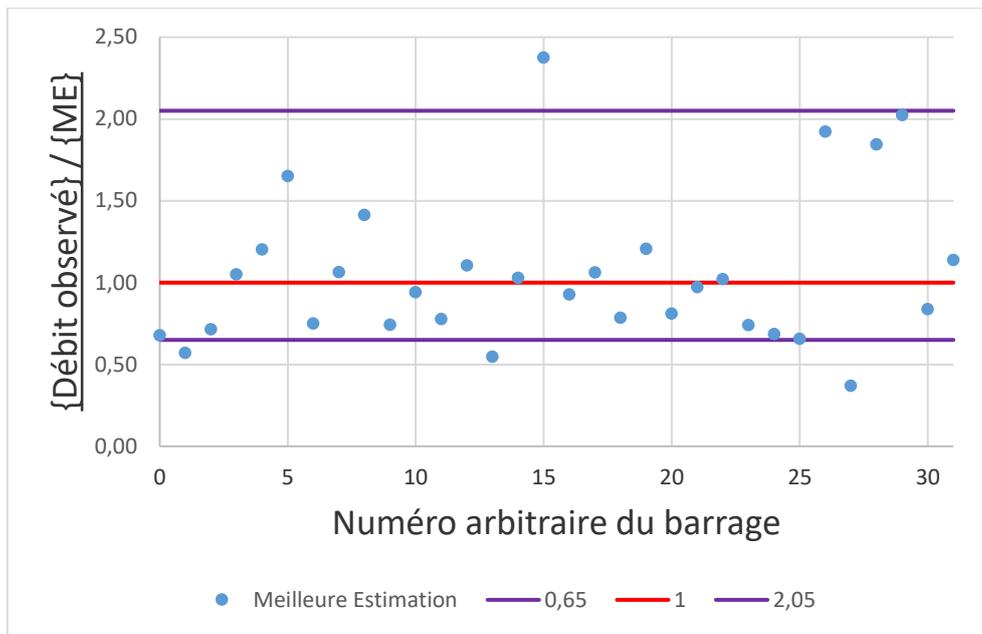
Figure 1. Observed flow to estimated flow ratio

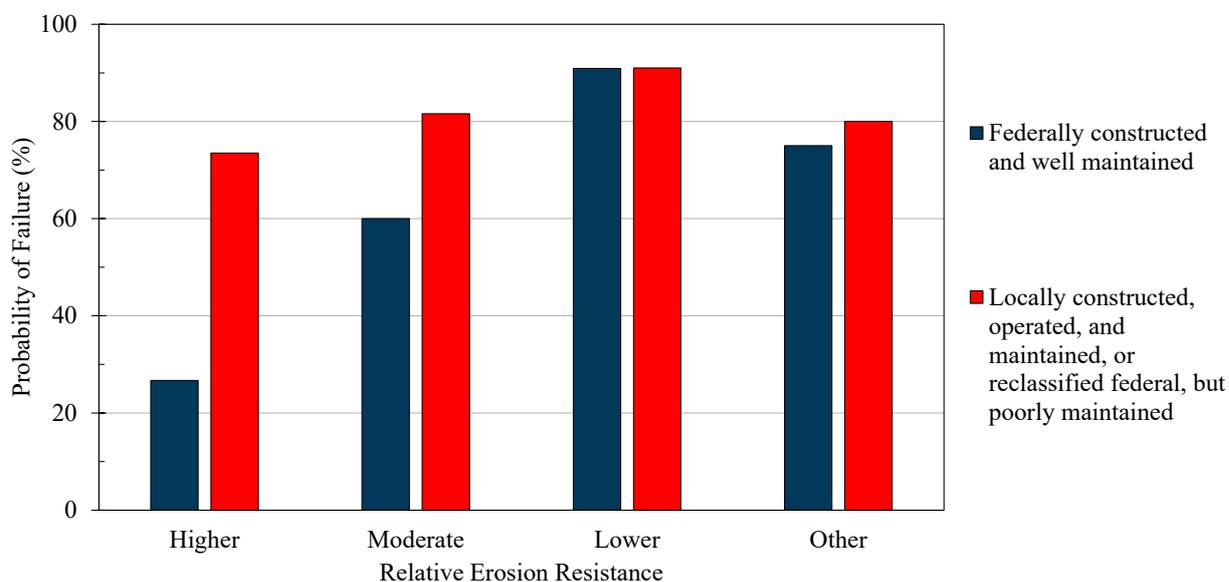
Figure 1. Probability of failure for less than 0.3 meter of overtopping as a function of relative erosion resistance and construction/maintenance quality.

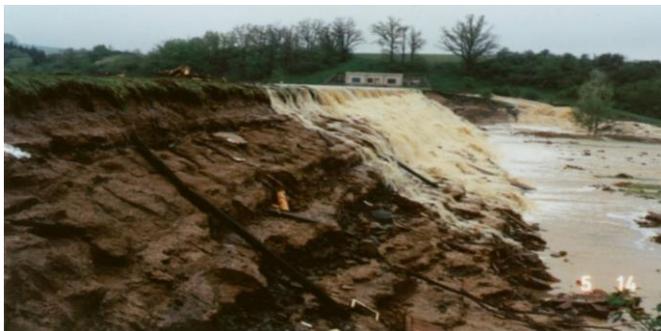
Figure 2. Overtopping of the dam Pocheň in 1996.

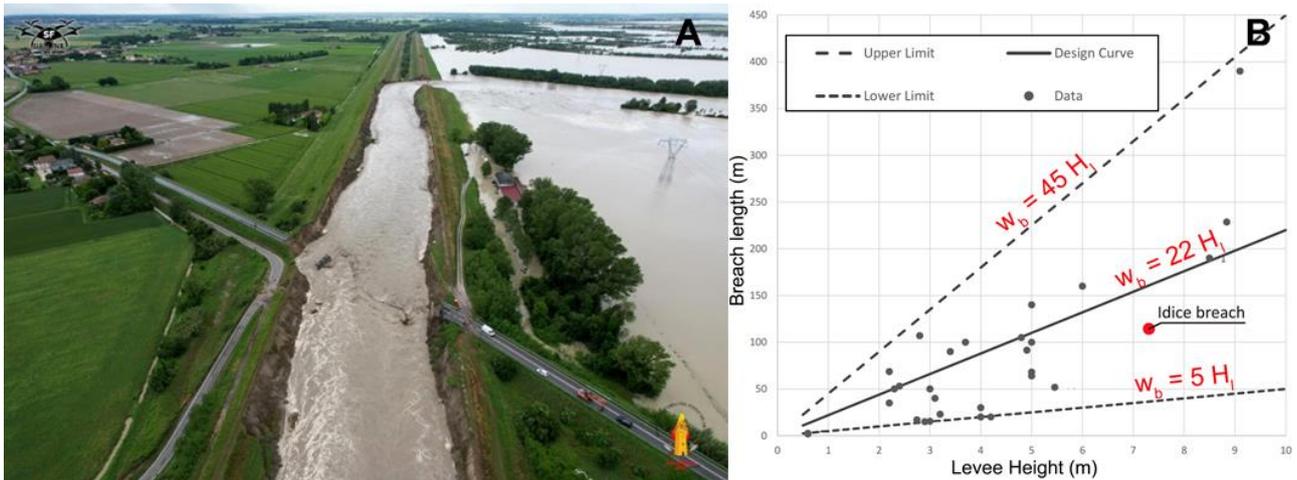
Figure 1. A) View of a breach and of a bridge failure occurred in the Idice river (Emilia-Romagna flood 2023). B) Design curves, modified after Zomorodi (2020), showing the final breach length as a function of levee height.

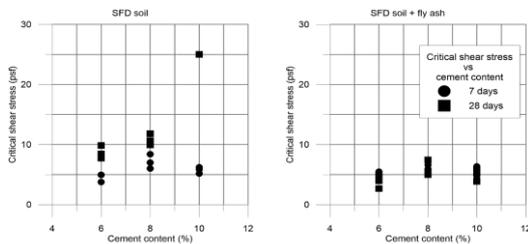
Figure 3. SFD soil test results

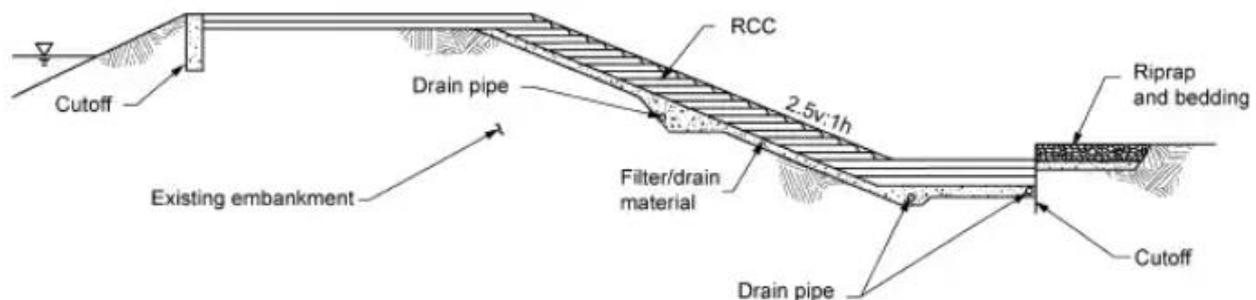
Figure 1. Typical design of RCC overtopping protection (FEMA, 2014).

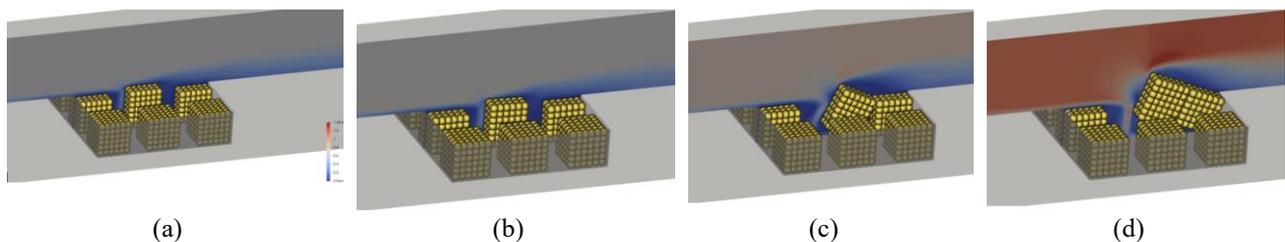
Figure 3. Erosion process of rock blocks

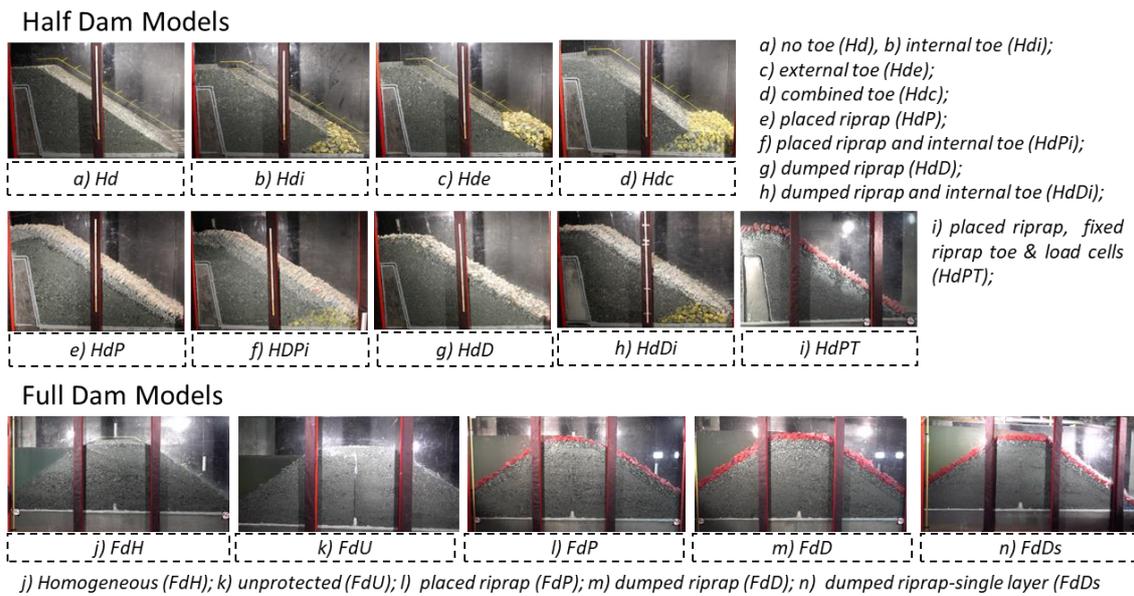
Figure 1. Experimental rockfill dam model setups investigated (1) Half Dam Models; and (2) Full Dam Models.

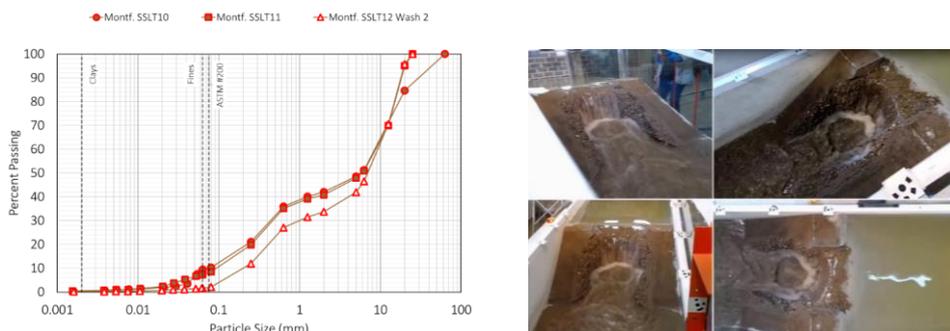
Figure 1. Grading curves used in this set of tests (left) and snapshots from the SSLT11 test (right).

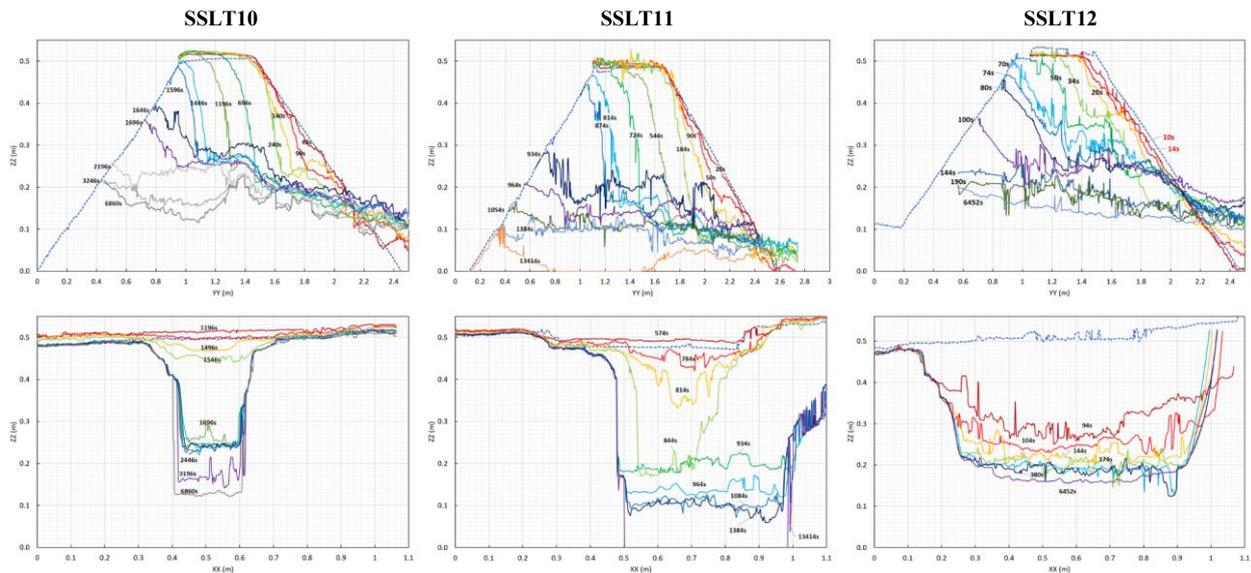
Figure 2. Breach evolution for tests SSLT10 (left), SSLT11 (middle), and SSLT12 (right). Times are all in relation to the initiation of overflow, i.e., when the reservoir level reached the notch invert elevation.

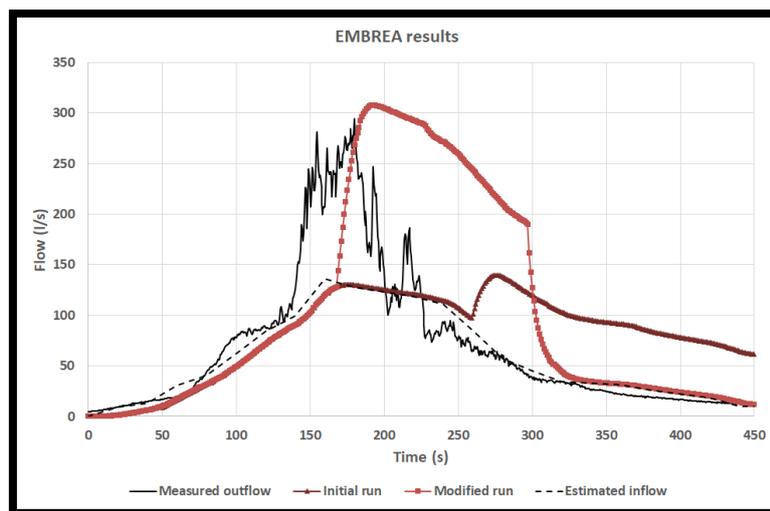
Figure 2: EMBREA headcut run results with initial and modified migration coefficients.

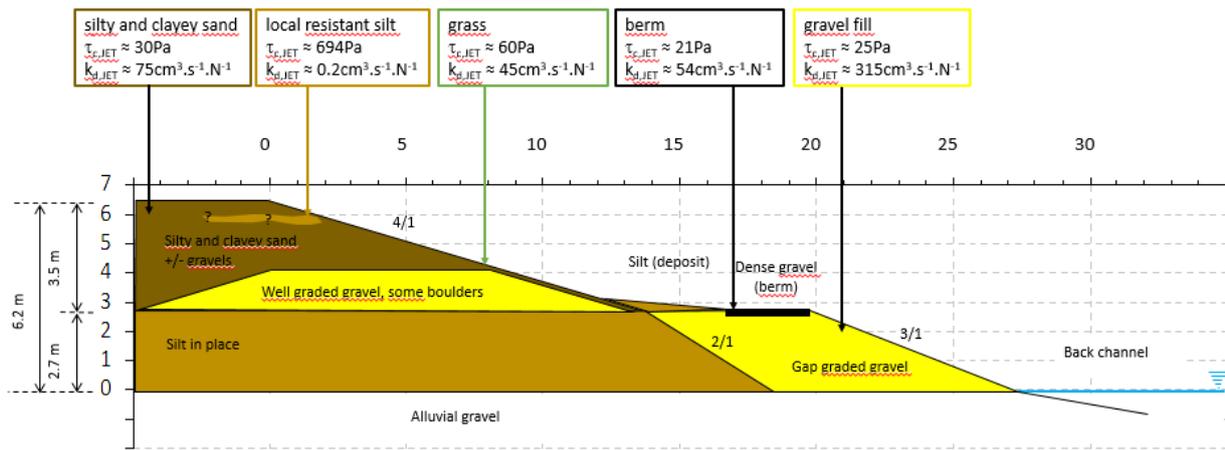
Figure 1. Cross-section of the dike, with JET characteristics measured in laboratory or on site

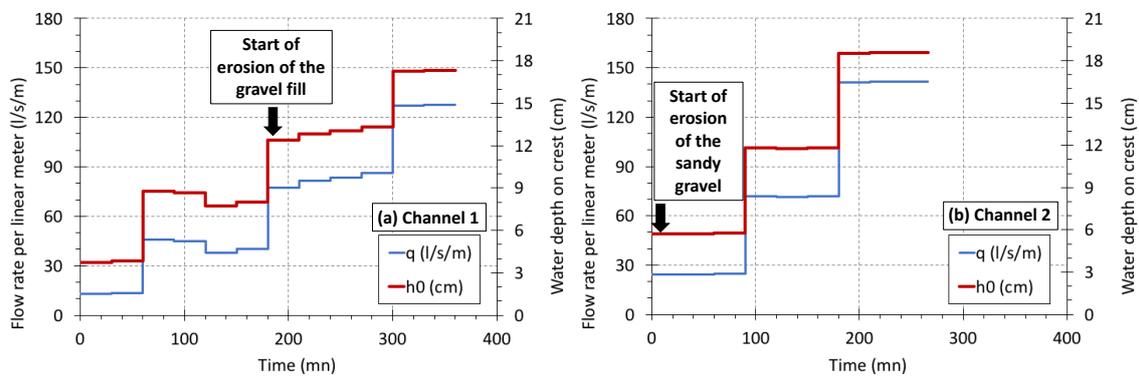
Figure 2: Flow sequence of (a) the 12 steps on Channel 1 and (b) of the 9 steps on Channel 2.

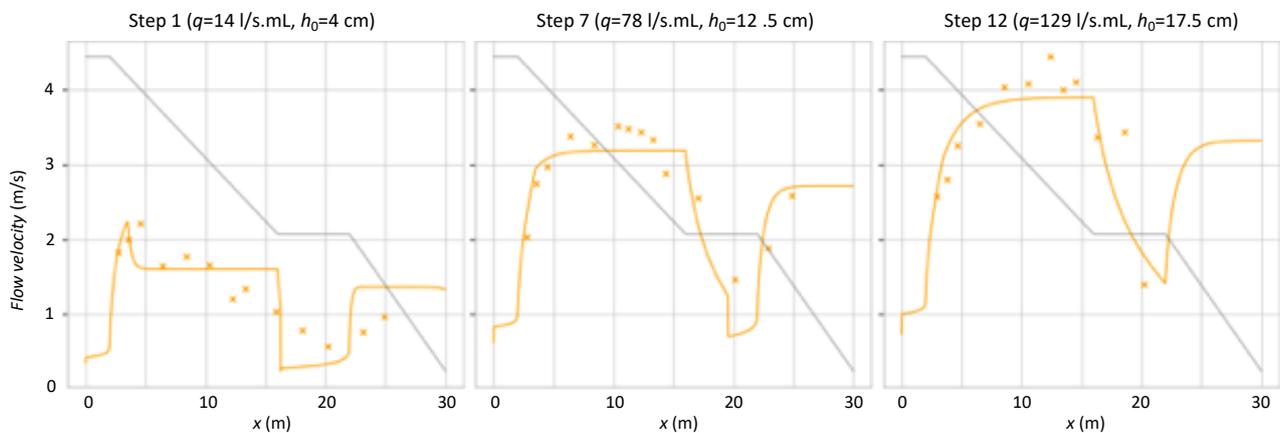
Figure 3: Comparison of measured (symbols) and modelled (continuous lines, TELEMAC 2D) flow velocities on Channel 1.

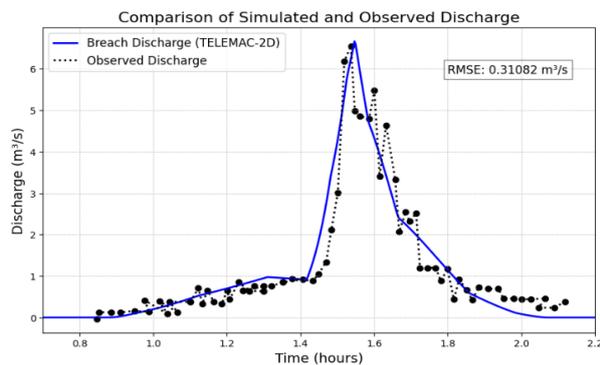
Figure 1. Simulated breach discharge and observed data from USDA ARS#1 test case

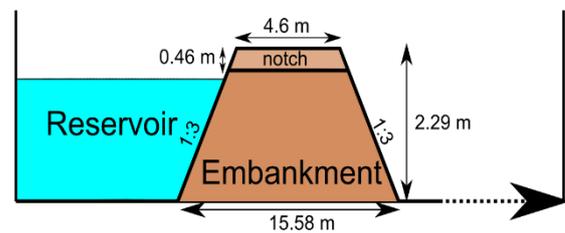
Figure 2. Geometry of USDA ARS#1 embankment

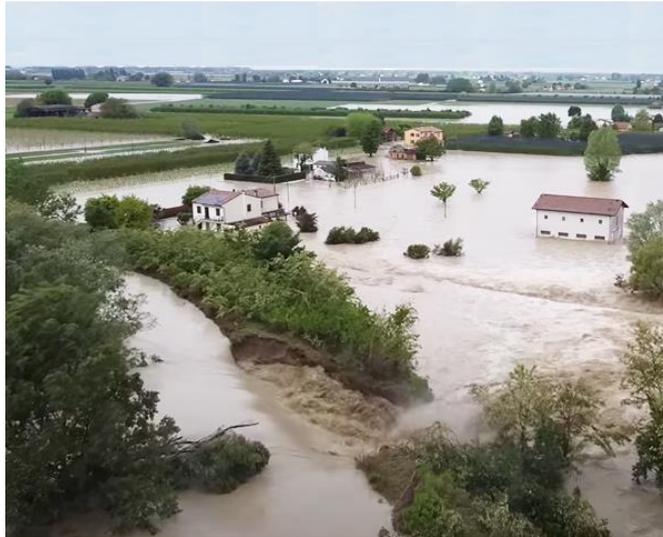
Figure 2. Aerial view of a breach occurred in the Lamone river (near Boncellino, Ravenna Province) during the 2023 flood event in Emilia-Romagna.
