30th Meeting of the European Working Group on Internal Erosion (EWG-IE)

The backward erosion piping phenomenon

The LIFE SandBoil project

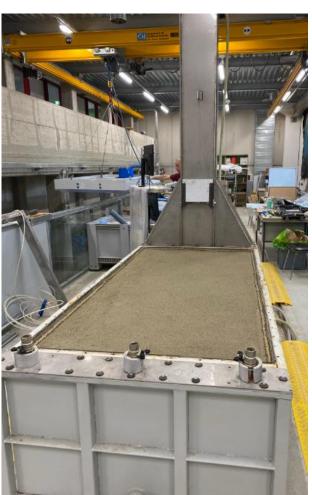
Sand pluviation

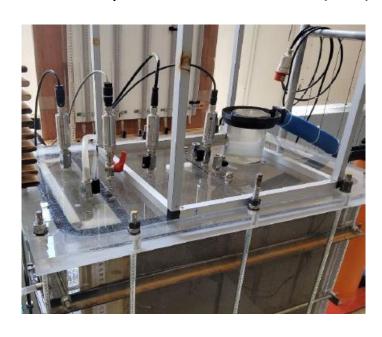
Pore pressure transducers (PPT)

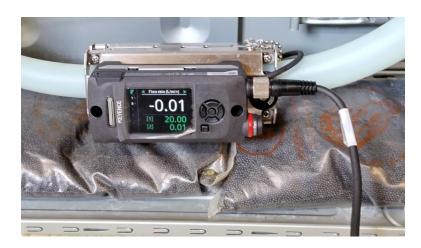
Flow meter/Load cell/Balance for manual measurements of the flow rate

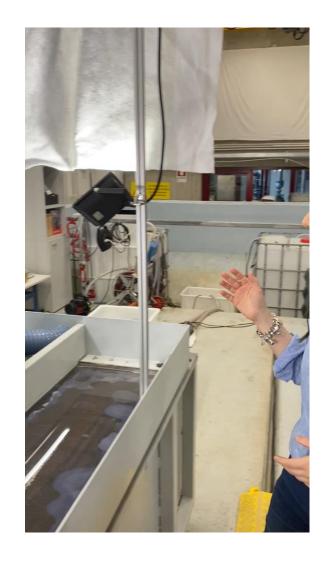
General view of the medium-scale apparatus

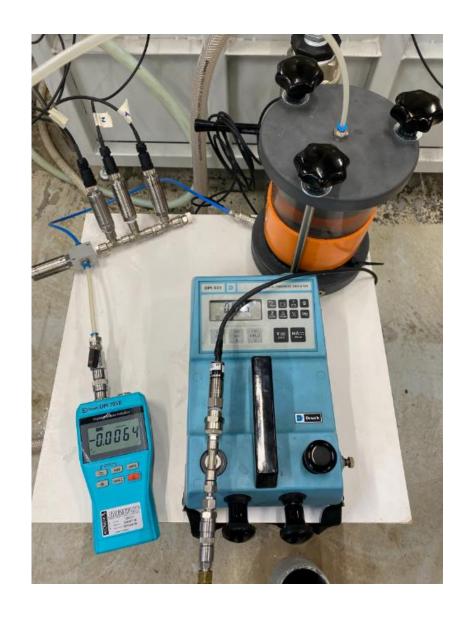
Monitoring system of the medium scale apparatus - PPT

Samples characterized by a higher relative density will soon be tested and the monitoring system for the medium-scale box will be integrated with optical fibers.
